None of your lip!

This guided 1mm rebater profiler could be worth its weight in gold to anyone who does a lot of kitchen refits

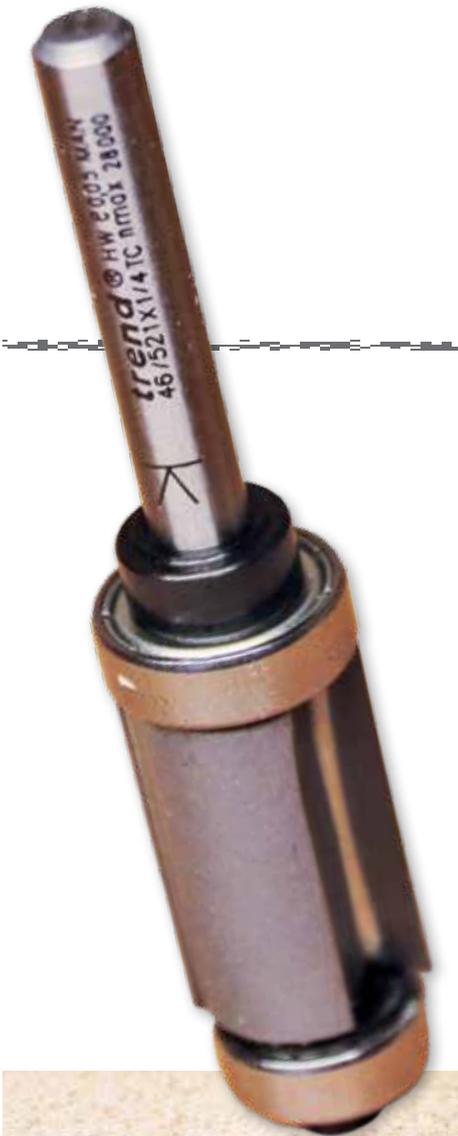
Looking to all intents and purposes like a top and bottom bearing-guided flush bit, it has a nifty trick up its sleeve by having a lower bearing that is 2mm shy of the 16mm cutter diameter.

Minimum work depth: 12mm

Max work depth: 38mm

Cutter diameter: 16mm

Lower bearing diameter: 14mm

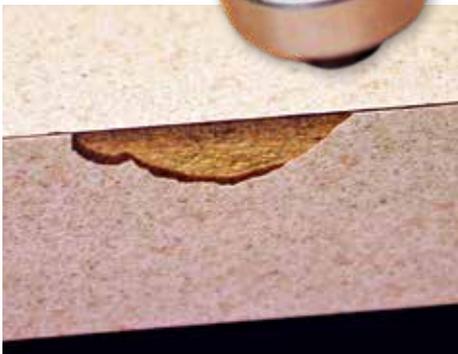
▲ A damaged lipping can be a pain to remove and replace

If you've ever had to deal with damaged laminate worktop lippings you'll know it can be a pain to remove them easily as well as dealing with the underlying contact adhesive so that a replacement can be successfully fitted. As long as the top can be easily removed, this cutter looks to be a great solution, allowing the damaged lipping to be removed in two hits.

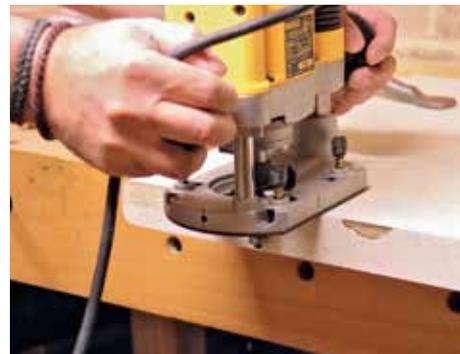
▲ Set the router to make the first pass just over half the depth of the worktop

By plunging the router low enough to make a pass just below half the thickness of the work it will make a 1mm rebated cut, removing the top part of the damaged lipping in doing so.

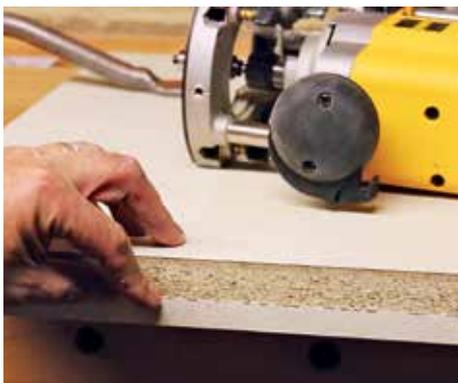
▲ The resulting cut removes the top part, leaving a clean surface

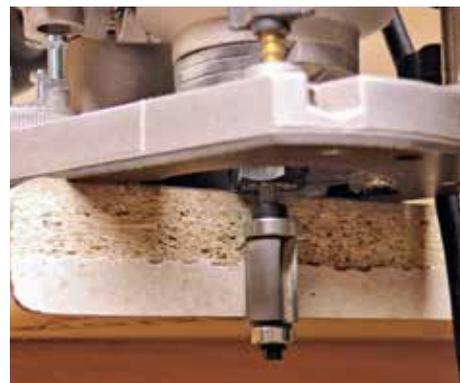
▲ Set the router so the top bearing engages the new rebate and is deep enough to remove the rest

Plunging the router further so that the flush-cut top bearing engages the newly formed rebate, the second pass now completes the cut and removes the bottom part of the damaged lipping to leave a clean flat cut ready for the new lipping.

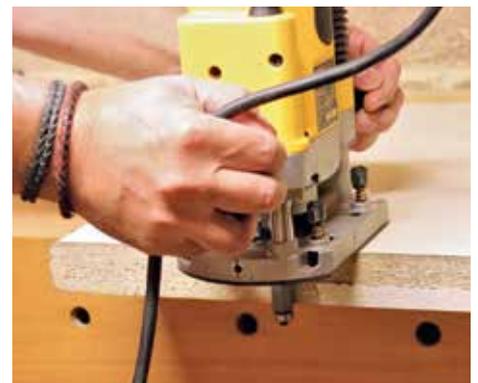
▲ A second pass then removes the rest of the lipping for a clean smooth surface

Putting it to the test on a damaged lipping the process was not only fast but left a perfectly clean and true edge ready for re-lipping.
